Residential Development in Kilcock, Co
Kildare

Stage 1 Road Safety Audit

Document Ref:	P19-009-RP-001
----------------------	-----------------------

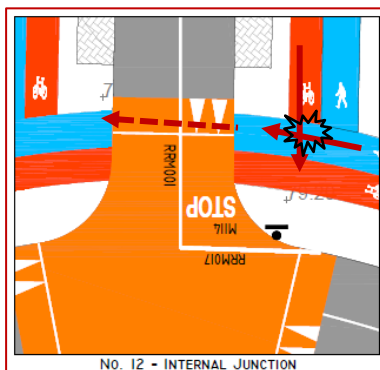
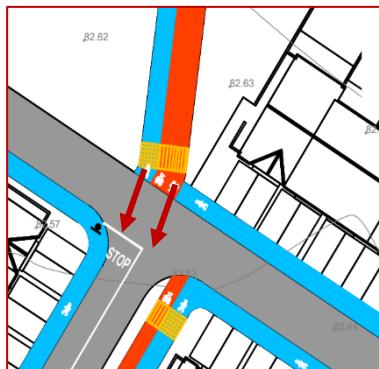
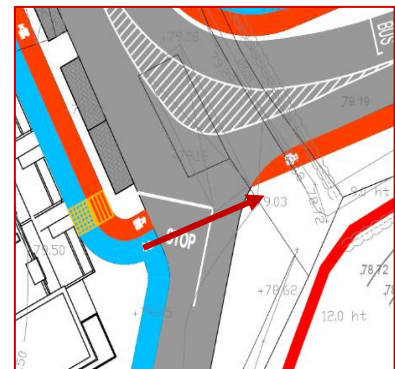
3.2 Problem

Summary: Pedestrian and Cyclist links not always clear, and sometimes direct VRUs into the middle of a junction.

Several footpath links do not appear to lead to a corresponding footway on the opposite side of the road. Upon entering the road or junction, mobility or visually impaired pedestrians may be unable to access the footway on the opposite side of the carriageway, and be forced to travel along the road edge until dropped kerb access is provided, which may increase the risk of being struck by a vehicle.

Also, Cycleway yield markings are not indicated where cyclist and pedestrians meet at junctions, or where cyclists enter the carriageway. Insufficient guidance for cyclists at the end of a designated cycleway may result in cyclists failing to yield to other road users, resulting in side-on collisions or pedestrian/cyclist collisions.

Additionally, pedestrian footways appear to coincide with the raised table 'ramp gradient', such that crossing pedestrians are either forced to walk on a sloped surface, or to enter the path of crossing cyclists. This could result in slips, trip and falls, or pedestrian/cycle collisions.

Ensure tactile paving, dropped kerbs, road markings and signage is used to support safe pedestrian and cyclist movement through the development.

Also, provide safe crossing points on pedestrian desire lines, and ensure visually and mobility impaired pedestrians can easily access the opposite side of the road at crossing points, and on a surface that is flat and level.

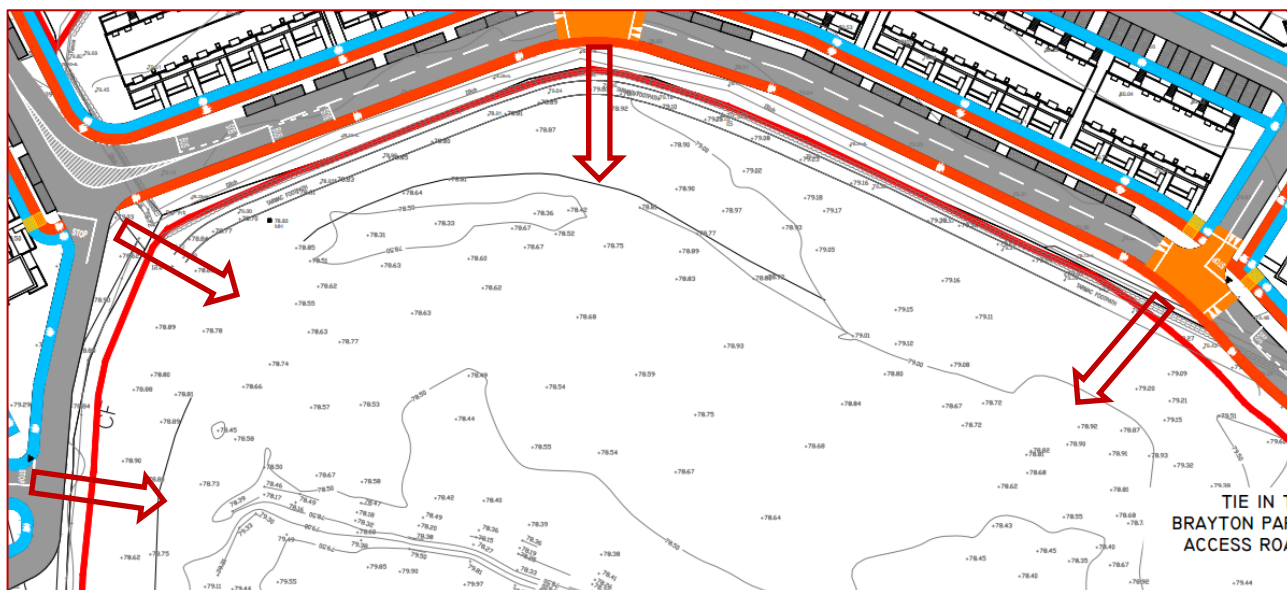
3.3 Problem

Summary: Unclear if there is sufficient interconnectivity between the proposed development and proposed playing pitches to the south.

It is not clear from the proposed plans if pedestrian and cyclist provision will be provided between the new residential development and the new playing pitches/walking paths to the south of the development. Pedestrian and cyclist connections or accesses are likely to be in high demand, which may lead to the development of unsafe and informal crossing points or accesses, which may give rise to slips, trips or hazards.

Provide safe crossing points and access links to the playing fields/walking paths, ensuring VRU desire lines are catered for in the development.

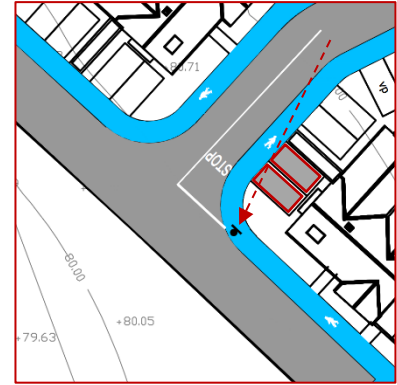
3.5 Problem

Location: Internal Junction No.1

Summary: Insufficient visibility to Stop signs

On plot parking may reduce visibility to Stop signs for approaching drivers, particularly where signs are positioned beyond the junction mouth radius. Failure to provide clear visibility to Stop signs may lead to late braking and overshoot collisions.

Ensure approaching drivers have clear visibility to Stop signs on approach to a stop control junction.

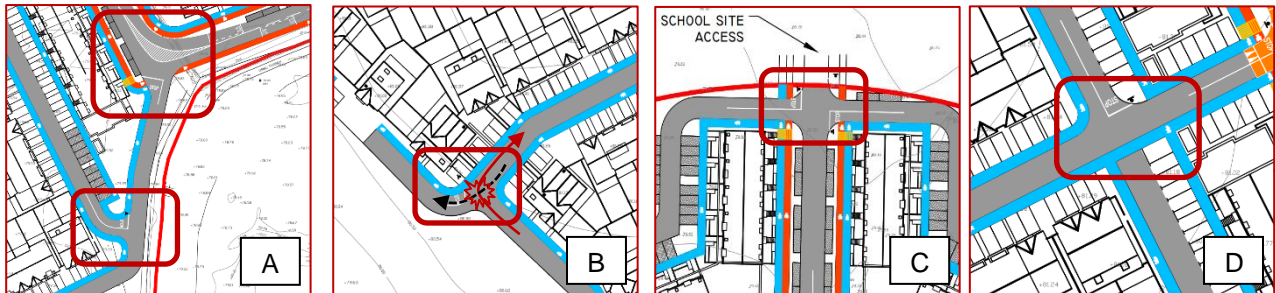
3.6 Problem

Summary: Junction layout strategy may lead to unsafe vehicle/VRU manoeuvres

Junction form and arrangement varies across the residential development, and may lead to driver confusion, unsafe vehicle manoeuvres, high entry/exit speeds and VRU confusion. The following examples have been identified.

- A. Junctions located at high demand bends may lead to a wide junction mouth that encourages high vehicle entry and exit speeds, particularly where visibility is limited. This could lead to overshoot or side-on collisions where drivers fail to reduce their speed on approach to the junction, or enter the junction without due care and attention.

Additionally, right turn vehicles on the main spine road will likely wait in the hatched area before completing their turning movement, which may lead to side-swipe collisions with buses travelling in the opposite direction (swept path analysis drawing confirms buses traverse hatch area).

- B. It is not clear if this junction is required, as it does not appear to serve any plot access or parking provision. The location of the junction could promote side-on collisions where right turning vehicles move across the path of a vehicle continuing right around the high demand bend.

- C. Crossroad junctions should be avoided where possible, as drivers approaching the Stop line may be unable to discern the crossing road at the junction, leading to vehicles entering the crossing road without slowing/stopping. This could result in overshoot incidents and side-on collisions with vehicles travelling on the major road. This problem may be exacerbated by the nearby school, which may experience high traffic volumes, informal parking and increased pedestrian/cyclist volumes.

- D. It is not clear if this is a cross road junction, or if the proposed footway is designed to create a Cul-de-sac arrangement.

- Crossroad junction: As above, priority control Crossroad junctions should be avoided, as drivers approaching the Stop line may be unable to discern the crossing road at the junction,

leading to vehicles entering the crossing road without slowing/stopping. This could result in overshoot incidents and side-on collisions with vehicles travelling on the major road.

- **Cul-de-Sac:** If a Cul-de-sac arrangement is proposed, it is not clear how large vehicles will perform a 180° turn. If HGV drivers are unable to turn their vehicle, they may be forced to reverse along the road where there is an increased risk of a rear-end-shunt, vehicle/pedestrian, vehicle/cyclist or material damage collision. HGV drivers may also attempt to mount the footway to gain access to the carriageway on the other side of the closure, leading to vehicle/pedestrian and side-on collisions.

A high-level review should be undertaken to identify junction forms and arrangements which are more consistent with DMURS, and better mitigate the problems identified above.

Additionally, the designer should determine if the number of junctions proposed is required, and seek opportunities to simplify the number of junctions within the development.

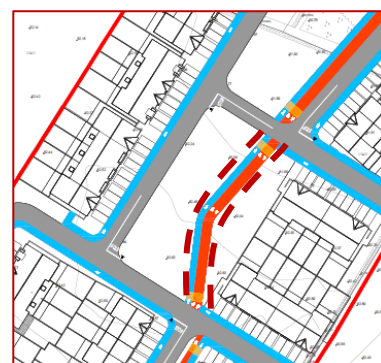
3.7 Problem

Location: Cycle/pedestrian track on the northern side of the proposed development

Summary: Locating cycle/pedestrian track through the middle of an open public space may lead to young children playing on the segregated track.

A cycle track and pedestrian footpath has been located through the middle of what is likely to be used as public open space. Young children using this space may frequently enter or cross the segregated route, leading to pedestrian/cycle collisions.

Revise the cycle/pedestrian track so that the public open space is maximised, such that it reduces the interaction between playing children and cyclists.

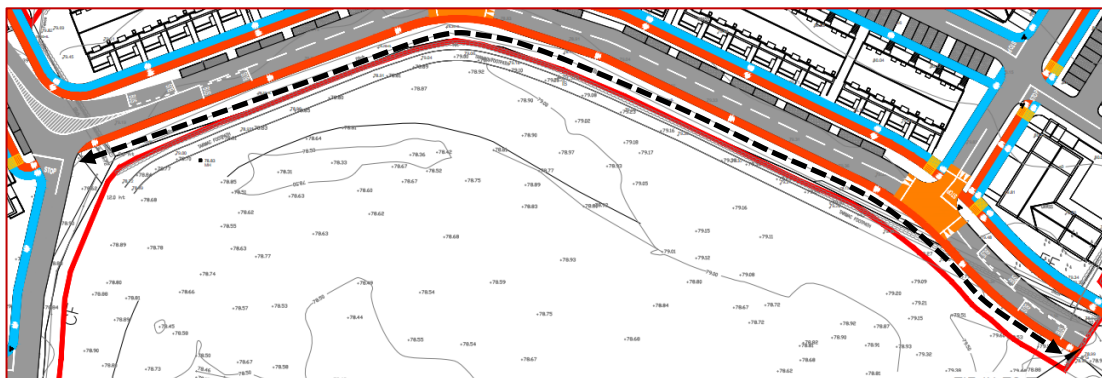
3.12 Problem

Summary: Pedestrian footway missing between entrance and high demand bend.

A pedestrian footway has not been provided between the development's entrance and the westbound bus stop located on the spine road. This route will serve as an important pedestrian route through the development, and for pedestrians wishing to access the playing fields and walking paths. It will also accommodate residents wishing to use the bus stop currently proposed.

Failure to provide a footway may lead to an informal path being created, which could lead to slips, trips and falls. It may also encourage pedestrians to use the cycle track, where there is an increased risk of being struck by a cyclist, or forcing cyclists to use the carriageway where there is an increased risk of being struck by a vehicle.

Provide a footpath along the southern side of the main road.

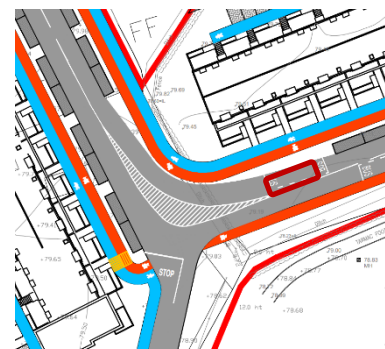
3.13 Problem

Location: Bus stop on spine road

Summary: Bus stop provided directly after high demand bend.

The eastbound bus stop has been proposed directly after a high demand bend. A stationary bus may not be seen by eastbound vehicles travelling around the bend, leading to rear-end-shunt collisions.

Ensure eastbound drivers have adequate SSD to stationary buses at the bus stop.
