Arboricultural Impact Assessment

Rycroft Homes Ltd

Lands at the townlands of Commons West, Boycetown and Kilcock, (lands adjoining the existing Brayton Park Estate), Kilcock, Co. Kildare

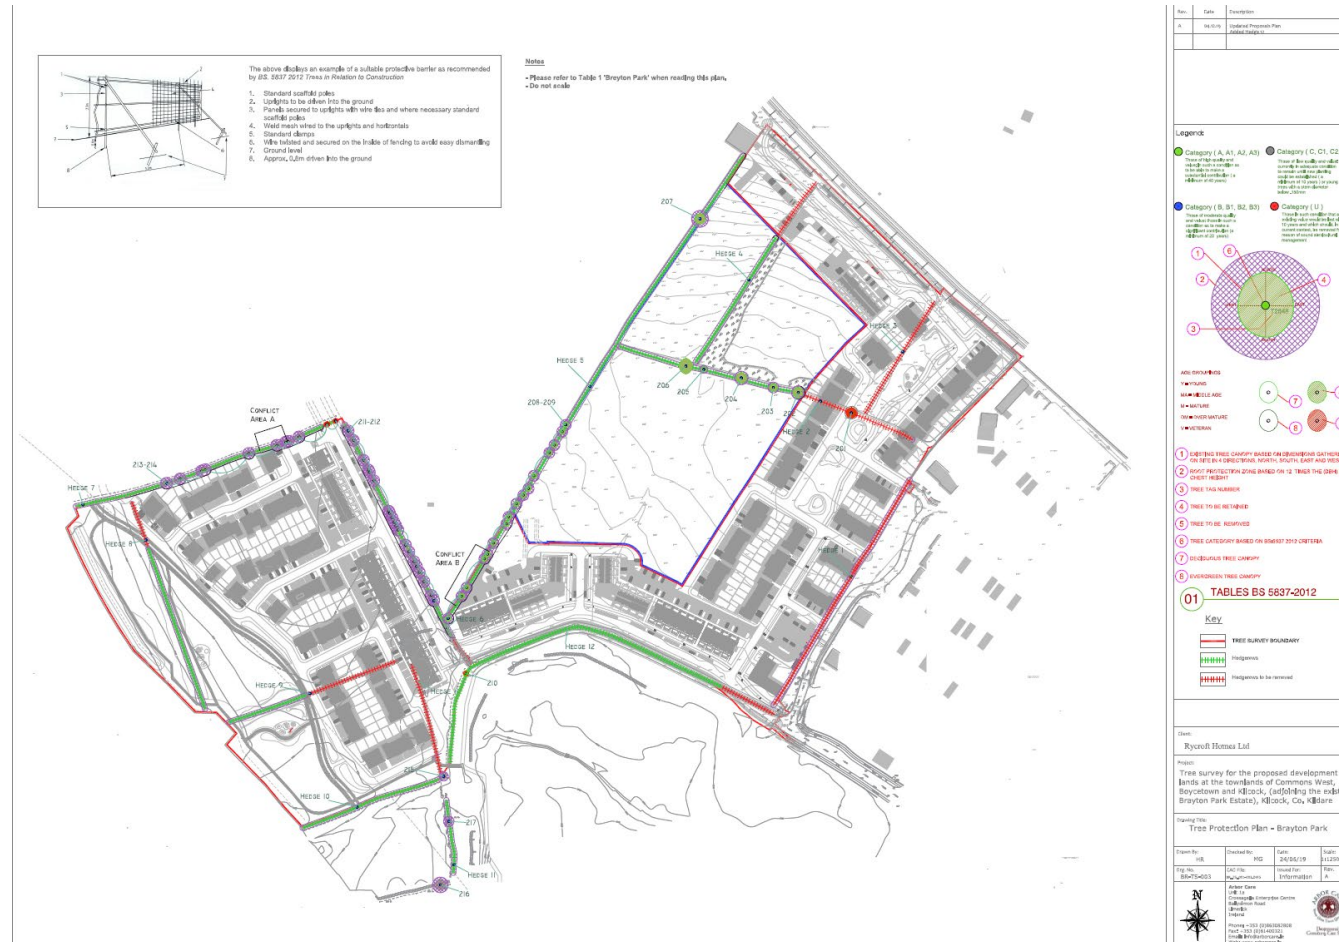
Appendix 3. Tree Protection Plan

It is proposed to remove 3 individual trees and sections of various hedgerows, please refer to table 1 and the tree protection plan for further information for more information. Two areas have been denoted as conflict area 1 and 2. There may be minimal impact to the hedgerows within these areas to accommodate paving/parking areas. However any impact will be low and may only involve disturbance to approximately 20% root disturbance which will have no long term negative impact on the trees.

The erection of protective fencing is to be erected to the fence line shown in the protection plan. The fencing must adhere with BS 5837: 2012 (Figure 2 and Figure 3 above). Signage must be placed on the fence to highlight its importance. Once the fencing is erected works can commence on-site.

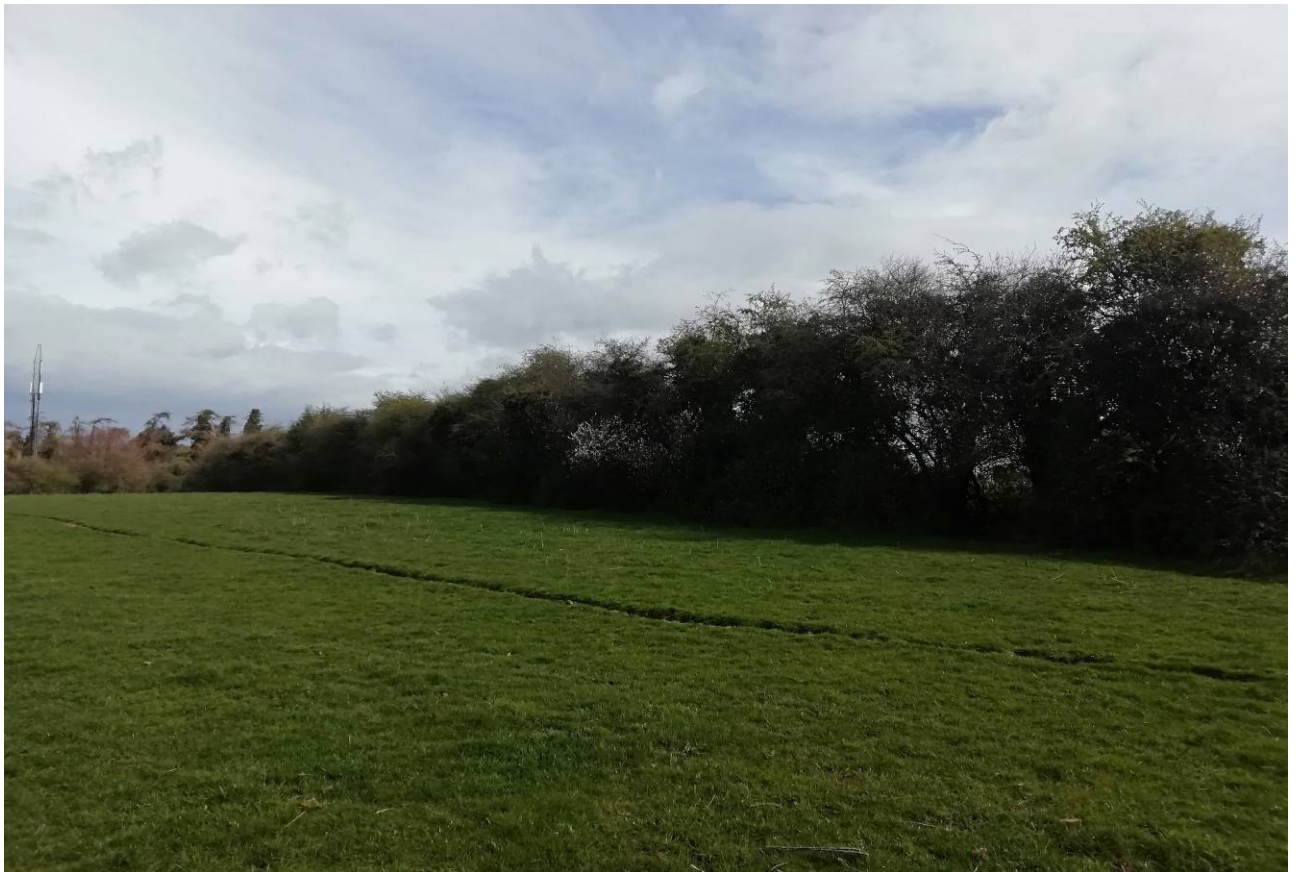
Figure 2. Typical hedgerow composition on the site

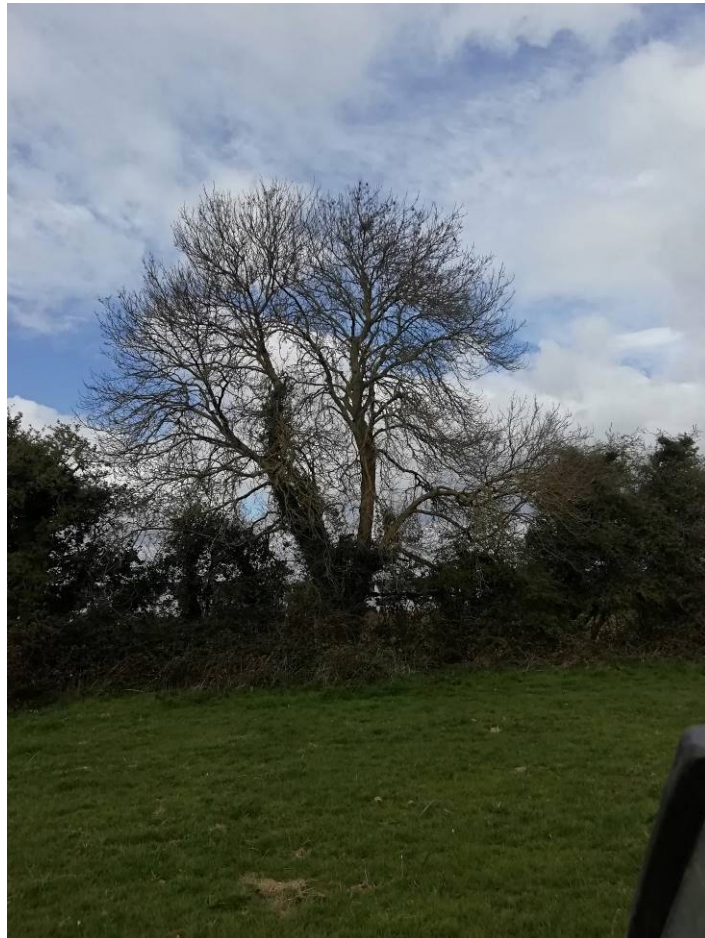
Figure 3. Typical Ash tree within the hedgerows
