Residential Development in Kilcock, Co
Kildare

Stage 1 Road Safety Audit

Document Ref:	P19-009-RP-001
----------------------	-----------------------

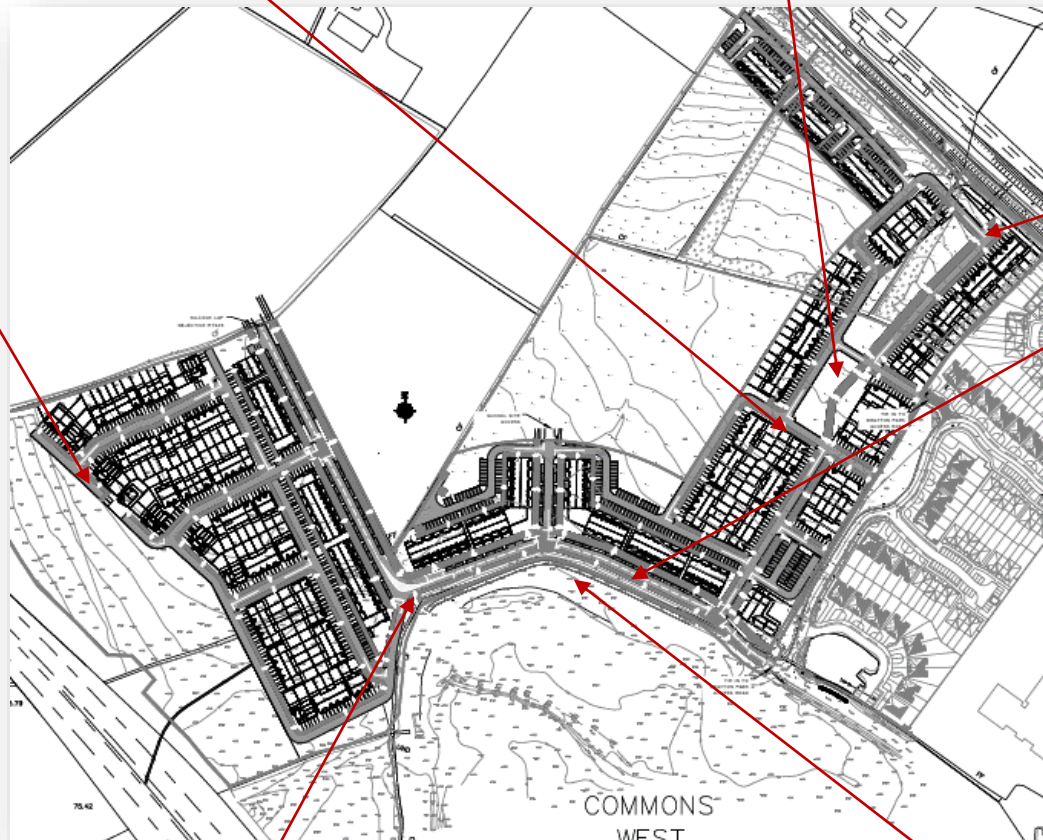
Summary: Pedestrian footway missing between entrance and high demand bend.

General Problem 3.11: Sign proposed on the cycle track

Problem 3.7: Pedestrian footway missing between entrance and high demand bend.

Problem 3.13: Bus stop provided directly after high demand bend.

Problem 3.3: Unclear if there is sufficient interconnectivity between the proposed development and proposed playing pitches to the south.
